SOUTHWEST RESEARCH INST SAN ANTONIO TEX
DEVELOPMENT OF DIAGNOSTIC TEST EQUIPMENT FOR INSPECTING ANTIFRI--ETC(U)
MAR 77 F N KUSENBERGER, J R BARTON

March 1977

4. TITLE (and Subtitle) DEVELOPMENT OF DIAGNOSTIC TEST EQUIPMENT FOR INSPECTING ANTI- FRICTION BEARINGS ✓		5. TYPE OF REPORT & PERIOD COVERED Final Report, Sept. 19, 1973 to Feb. 28, 1977 ✓

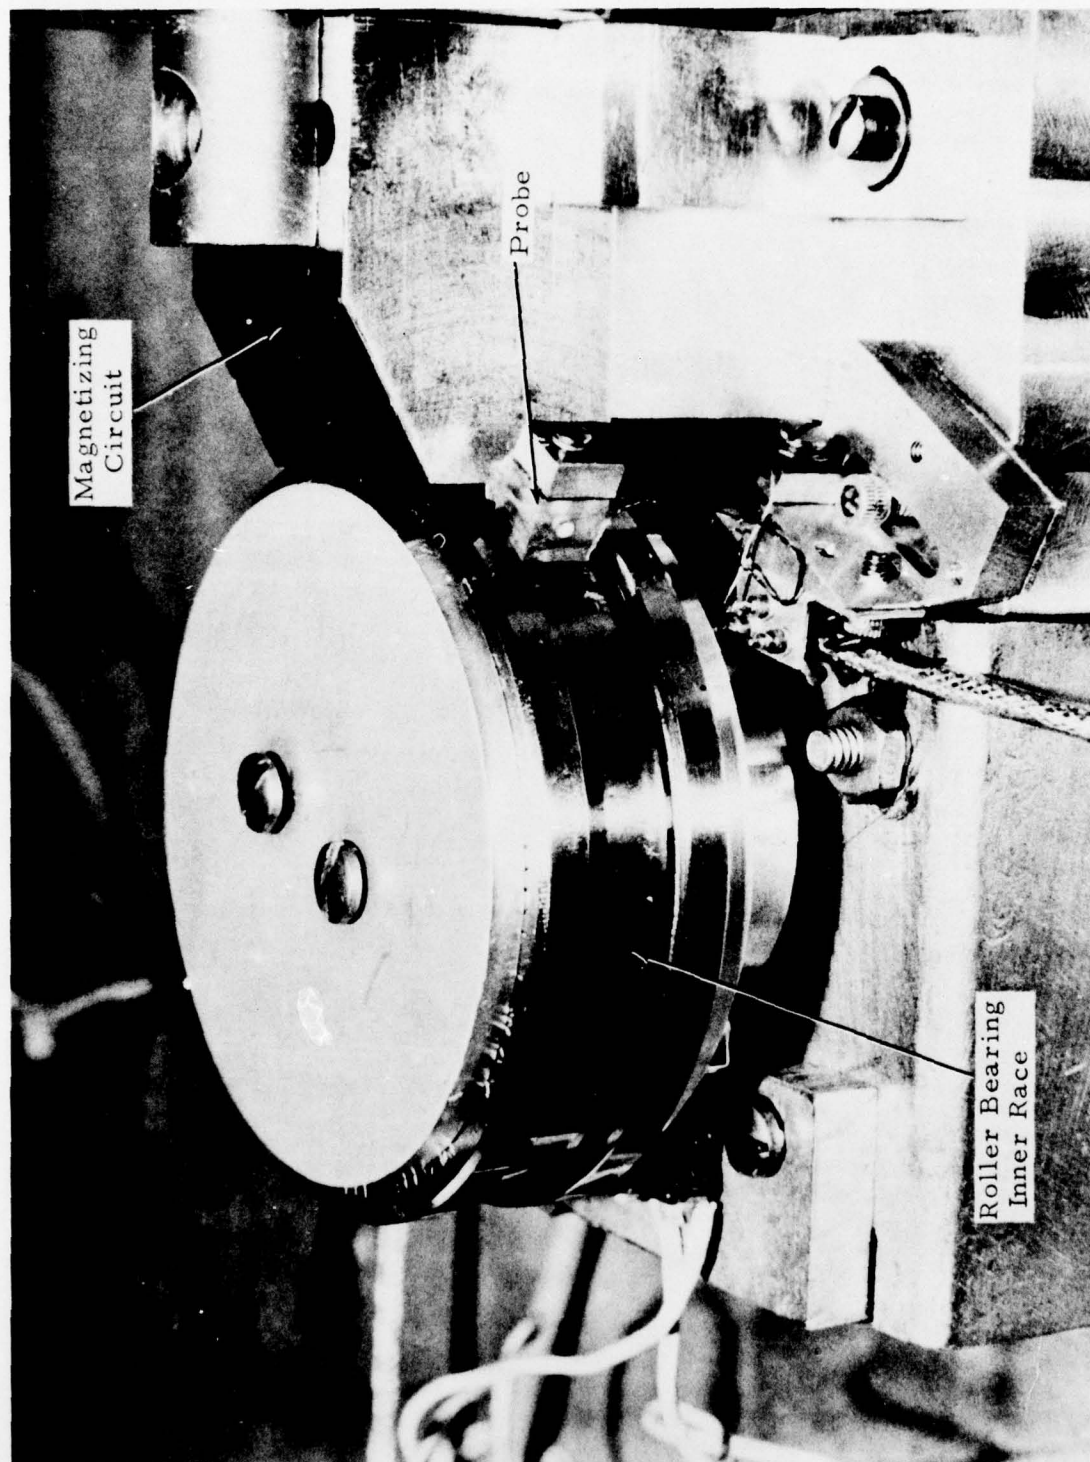
FIGURE A12. ROLLER BEARING RACE, PROBE, AND MAGNET POLE PIECE ARRANGEMENT USED FOR CONTINUOUS BARKHAUSEN EXPERIMENTS

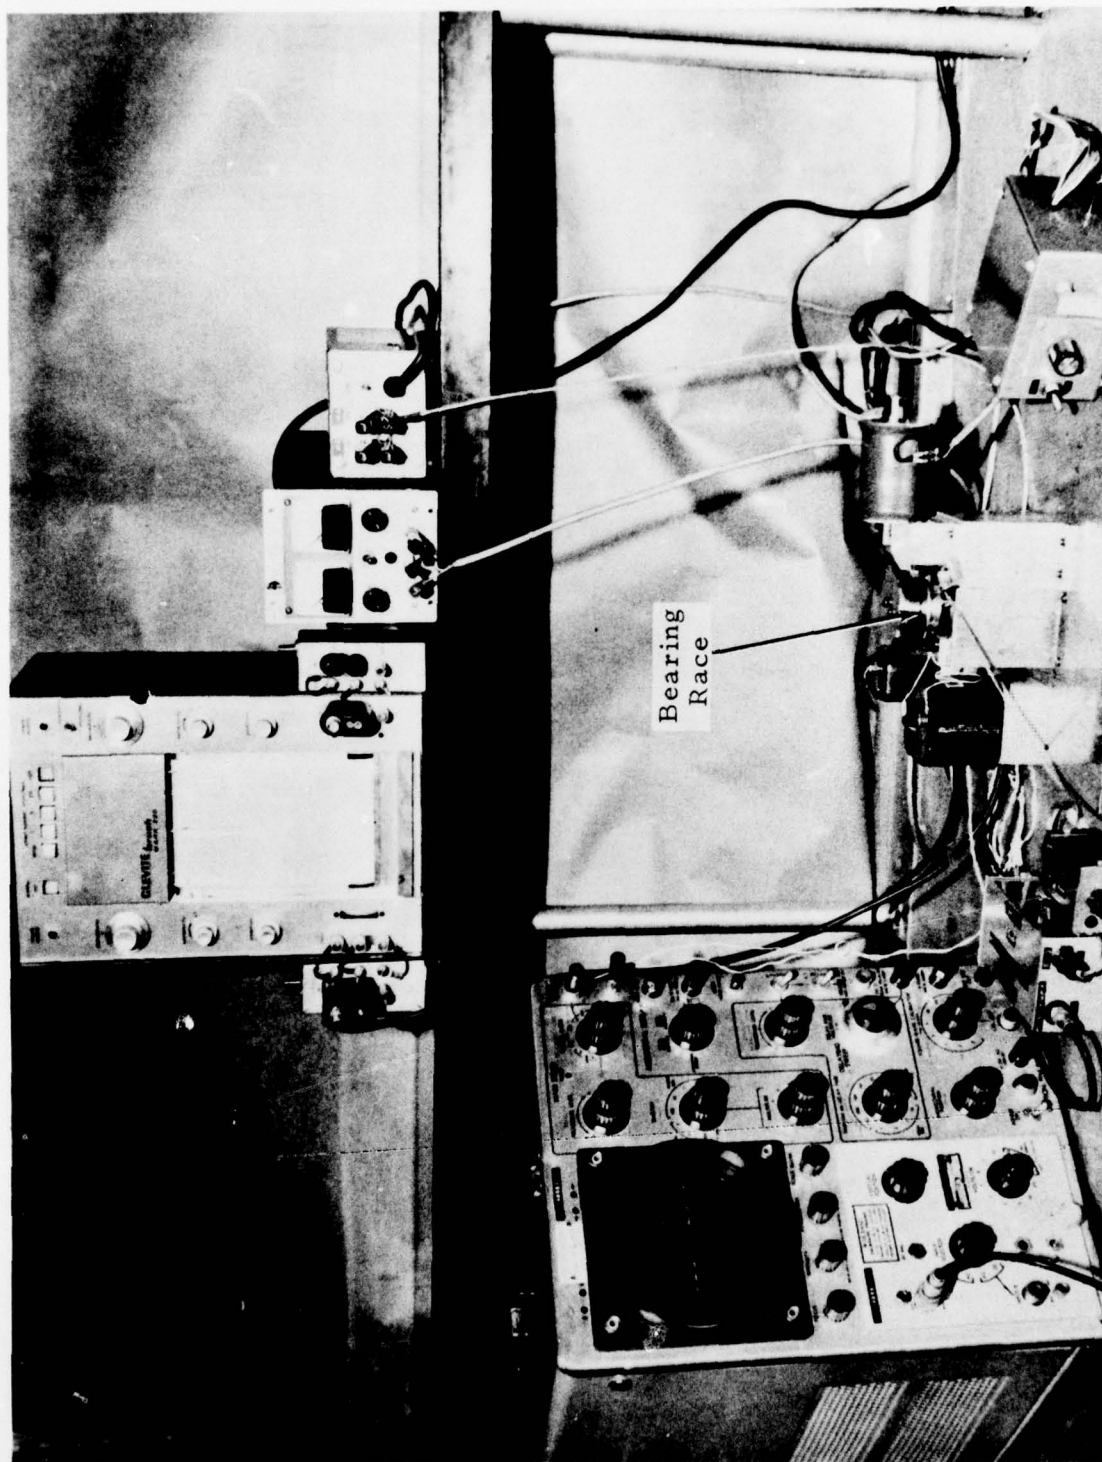
FIGURE A13. CONTINUOUS BARKHAUSEN APPARATUS FOR ROLLER BEARING RACE

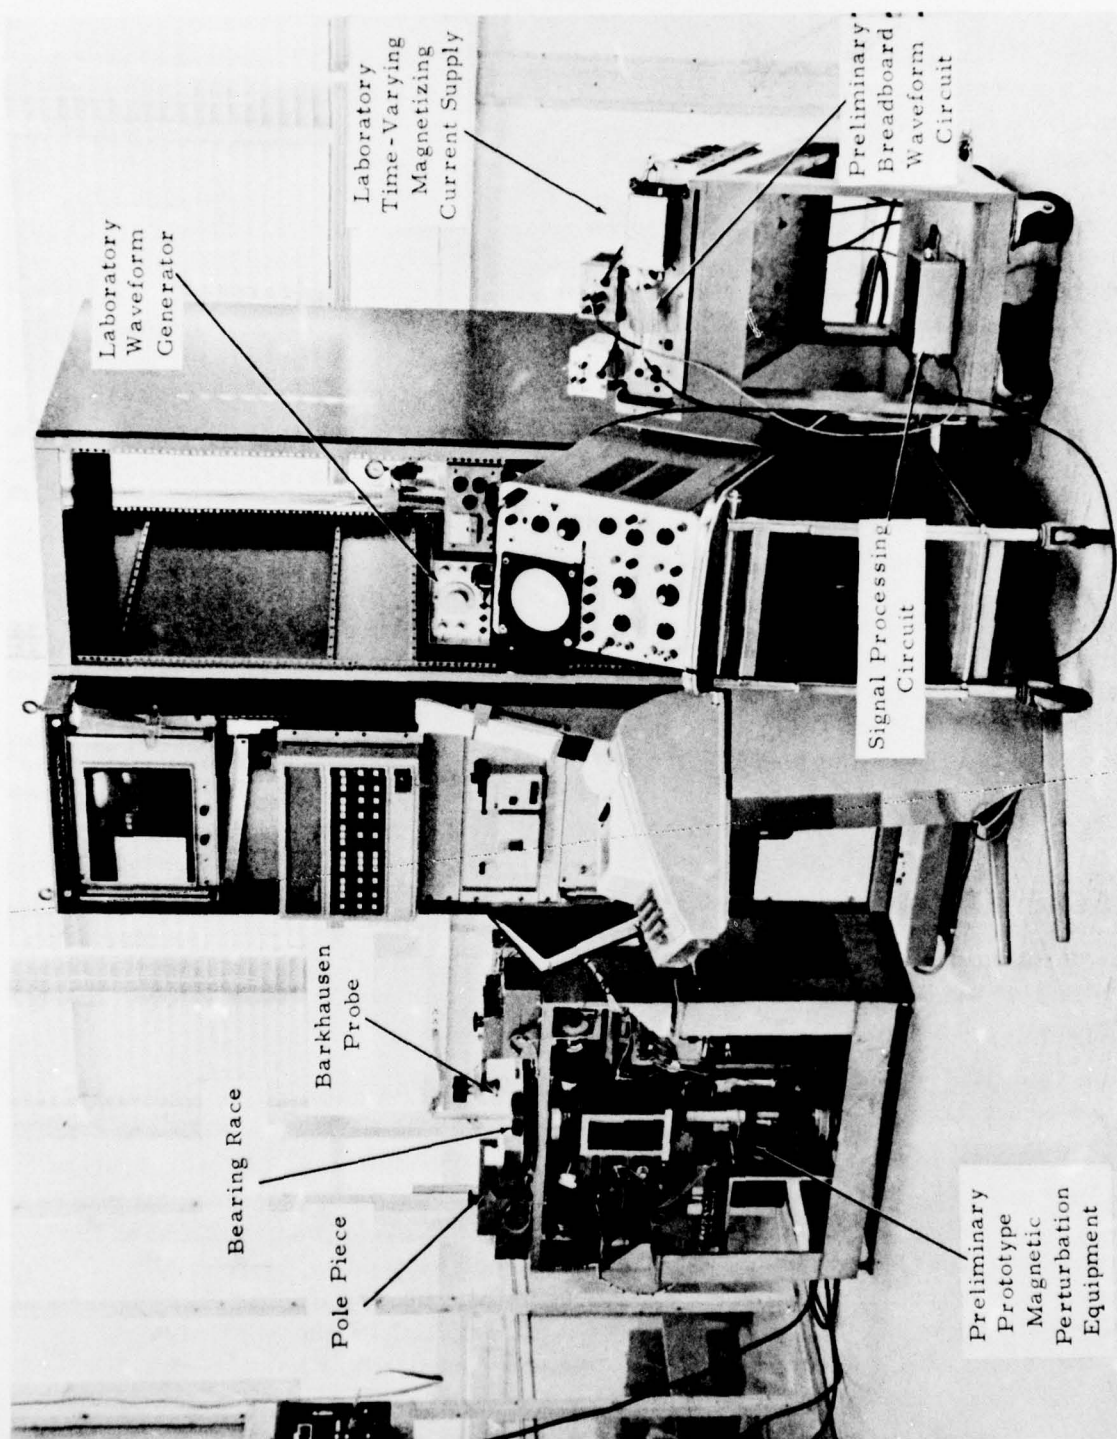
FIGURE A14. OVERALL VIEW OF PRELIMINARY PROTOTYPE UNIT DURING DEVELOPMENT OF BARKHAUSEN INSTRUMENTATION

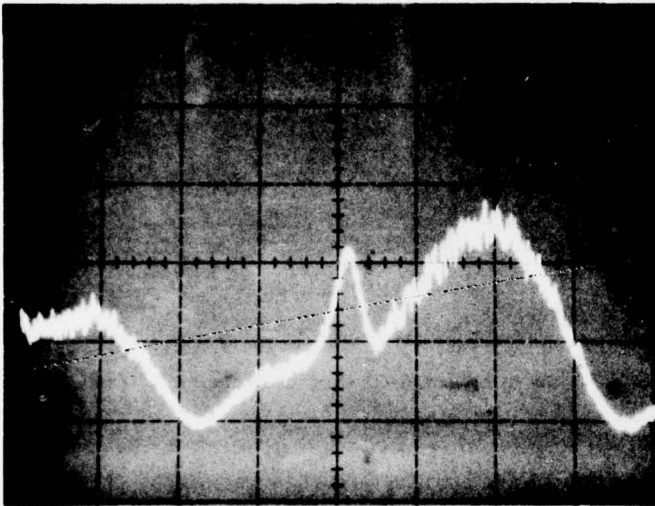
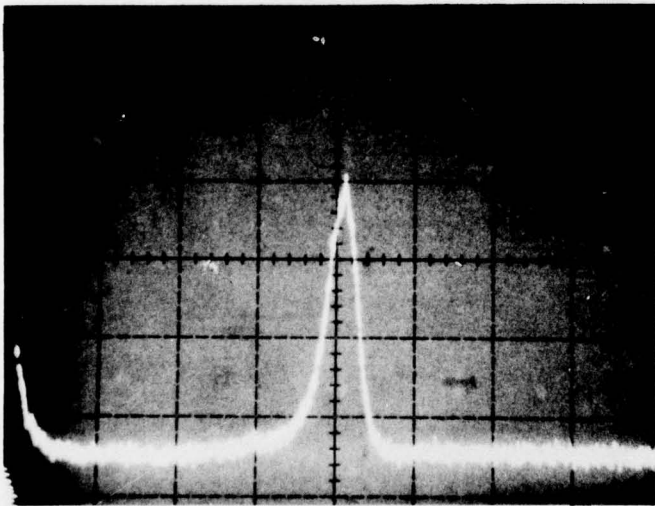
Normal Air Coupling

Probe Air Off

of this accessory set was postponed pending further checks on this Barkhausen signature. Furthermore, during operational checkout of the preliminary prototype unit, an unusual Barkhausen signature was noted on the 1-300-015 outer race which contained shape characteristics very similar to those observed on the 204-040-346/205-040-246 inner race accessory set. This anomalous Barkhausen signature shape was not noted for the same 1-300-015 outer race on the prototype (CCAD) system. In-depth investigations were made by changing out Barkhausen probe, preamplifier, and other signal system components several times but the improper Barkhausen signature persisted. However, when the unprocessed Barkhausen signature was viewed on a much expanded time scale, a periodic signal of approximately 200 kHz was observed to occur in synchronization with the time-varying applied magnetic field. Subsequent investigation revealed that the probe coupling air was inducing a high frequency mechanical vibration (~ 200 kHz) in the Barkhausen probe pickup coil which resulted in the generation of an electrical signal in the Barkhausen probe via the time-varying applied magnetizing field. The influence of the probe coupling air is illustrated by the records in Figure A15. Note the anomalous Barkhausen signature in the upper record with normal air coupling and the absence of the anomalous signal component when the probe air is turned off (see lower record). It was concluded that i) in those cases where the anticipated Barkhausen signature shape is obtained, all probe coil turns were bonded to the probe coil form, and ii) in those cases where an improper shaped signature was obtained, the face turns of the probe coil were not tightly bonded to the coil form. Based on this rationale, new Barkhausen probes were fabricated where all coil turns were carefully bonded to the coil form. The results of this effort in alleviating the air-induced mechanical vibration problem was previously illustrated in Figure 12 in this report.
